Bulletin Number: 20112019

Date: November 27, 2019
Product: MAC(F) / MAH(F) Series - All Serial Numbers
From: Technical Service Department
Title: Gasket Removal Two-Pipe Venting

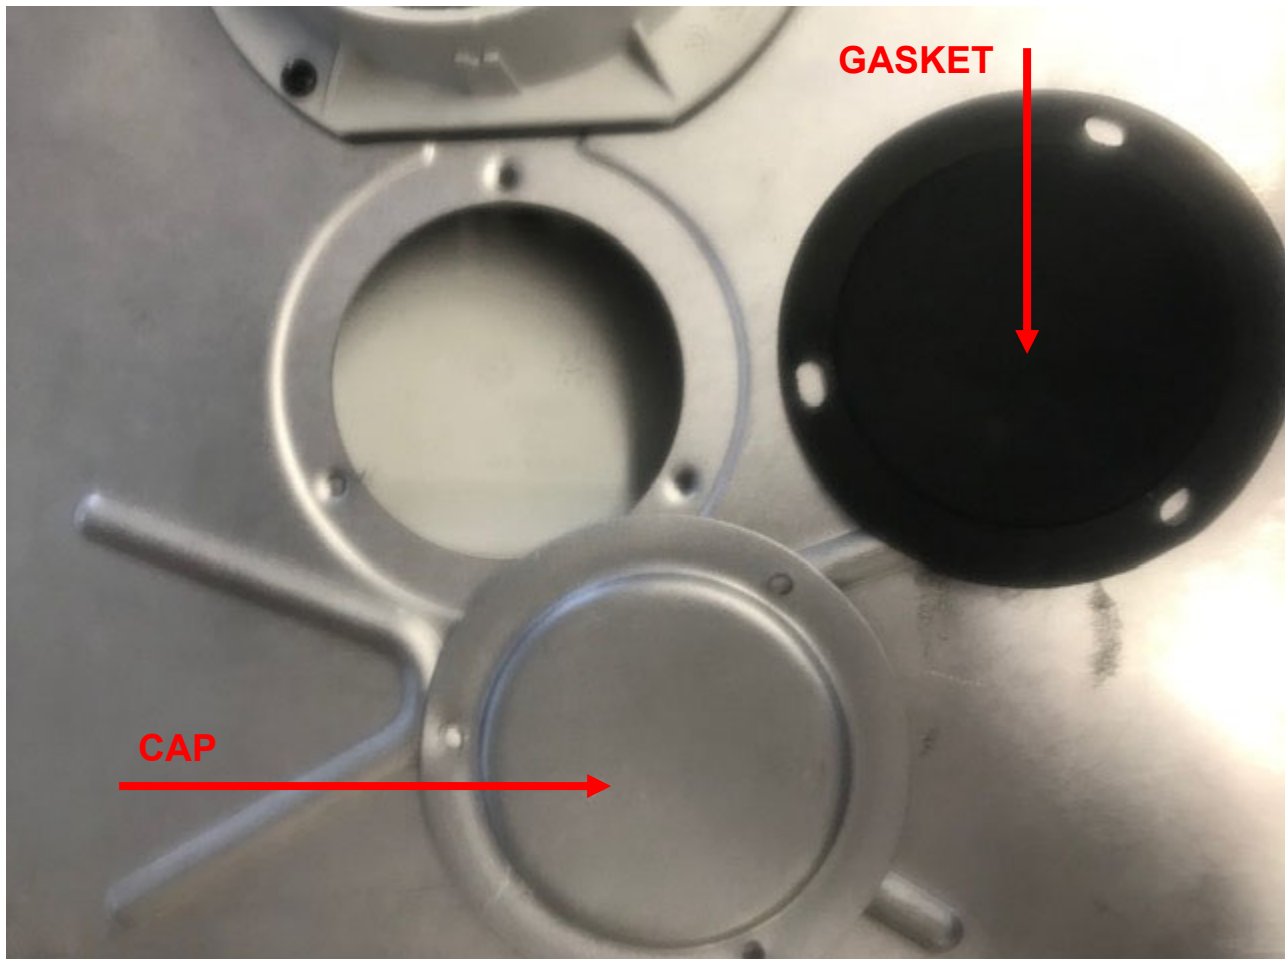
When converting from single-pipe venting to two-pipe venting, the cap and gasket must be removed. In some instances, it has been found that the cap was removed but the gasket was left in place. This can lead to the boiler displaying an Error Code 53.

ECR will be adding a label to remove the gasket when converting from single-pipe venting to two-pipe venting.
