Technical Bulletin

BULLETIN NO. 231110

PRODUCT: 2021 MGB K-Series

TITLE: Pilot adhesive change

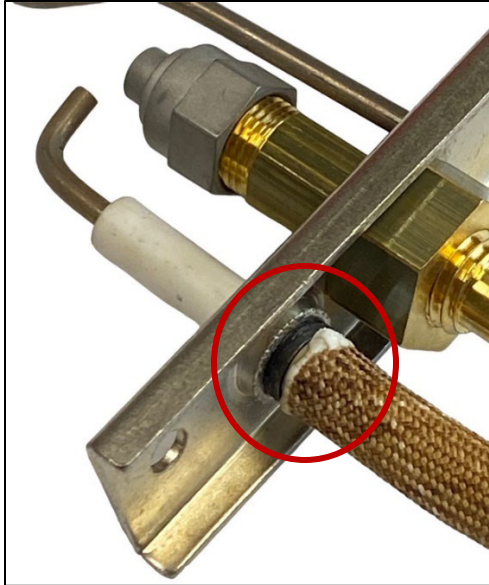
Infrequent field reports of nuisance failures associated with the MGB-K series boilers has prompted a change to the pilot assembly. The change eliminates any potential for electrical continuity created by the adhesive that holds the fiberglass sleeve in place. Electrical continuity in the area of the pilot ignitor can interfere with the flame rectification circuit and cause a nuisance shutdown.

The primary symptom is the pilot lights but the main burners are not activated. You may also notice in some cases that the ignitor continues to spark after the pilot is lit. For boilers utilizing the Resideo (Honeywell) S9361A control, the control may display an error E-57 or an erroneous error code.

Photo 1: Original location of adhesive

1. Temporary fix: Roll back the fiberglass sleeve and remove the adhesive. The adhesive can be removed by scraping it away. Use a wire tie at the opposite end of the fiberglass sleeve to hold it in place so that the pilot end covers the igniter.

2. Permanent Fix: Replace the pilot assembly, kit no. 550003793. Ensure the new pilot does not have adhesive on the igniter end of the fiberglass sleeve.

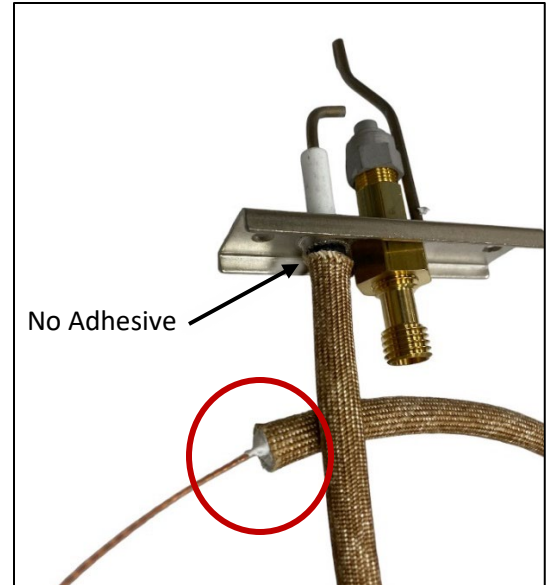
To prevent any possible electrical continuity between the ignitor and ground the adhesive used to hold the fiberglass sleeve in place has been moved from the ignitor to the other end of the sleeve. This was a rolling change implemented in March of 2023. See photos 1 & 2.

Photo 2: New location of adhesive
