**Bulletin Number: UTB-071519**

**Date: July 15, 2019**  
**Product: Steam Boilers**  
**From: Quality**  
**Title: Heat Exchanger Failures and Maintaining Steam Boilers**

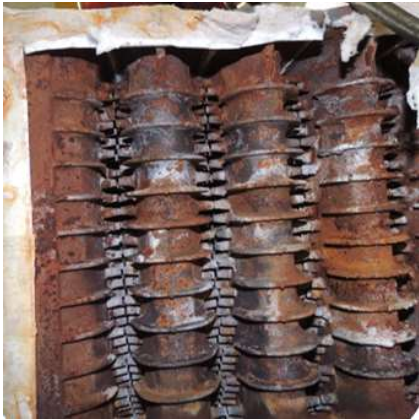
Overheating

Steam boilers require regular maintenance (at a minimum yearly). The result of failing to perform this required maintenance is poor performance and drastically shortened heat exchanger life and may result in the denial of warranty coverage.

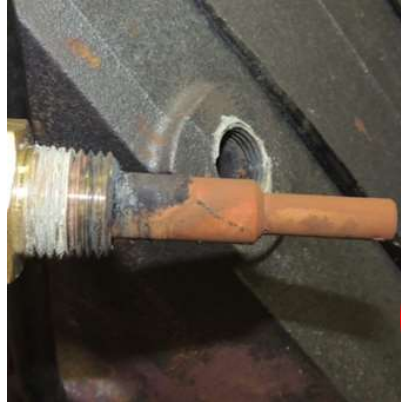
LWCO Probe fouled

Bringing in makeup water creates two issues. The first is oxygen. Oxygen is entrained in the water and when heated in contact with the cast iron heat exchanger, attacks the metal at and above the waterline. All water also has other impurities in it including dissolved minerals, metals, etc. As the makeup water is brought into the boiler so are these additional impurities. As the water steams, these impurities are left behind in the heat exchanger and form a coating on all the internal surfaces, including the LWCO probe. The coating reduces efficiency because the heat exchanger is now "insulated". As the heat exchanger gets more and more insulated the temperature of the heat exchanger keeps rising until it reaches the failure point. If the LWCO probe becomes coated it will fail to function properly. The tip of the probe must be able to sense an electrical signal to work properly.

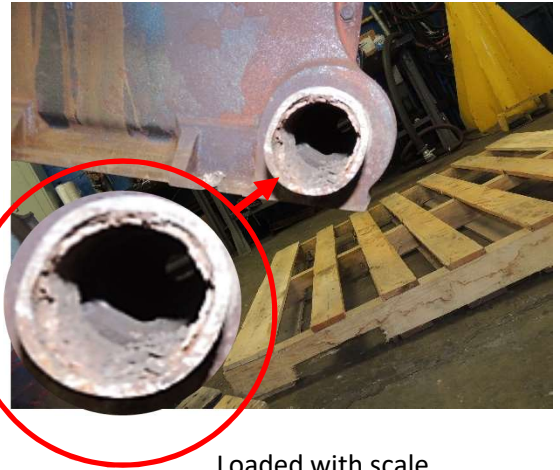
Loaded with scale

Failures caused by scale build up are due to neglect and not considered to be manufacturing defects. They are not covered by the warranty.

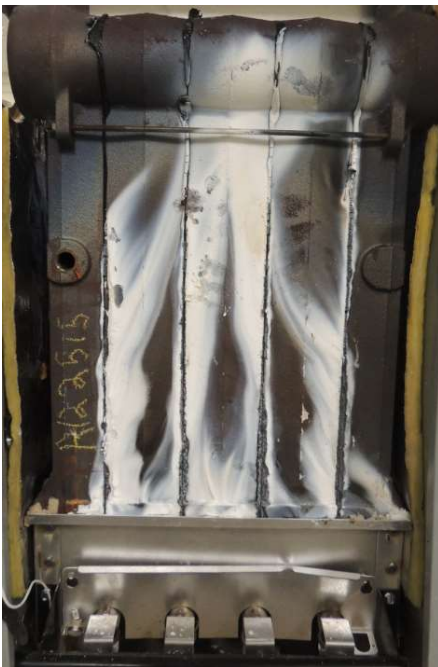
Overheating

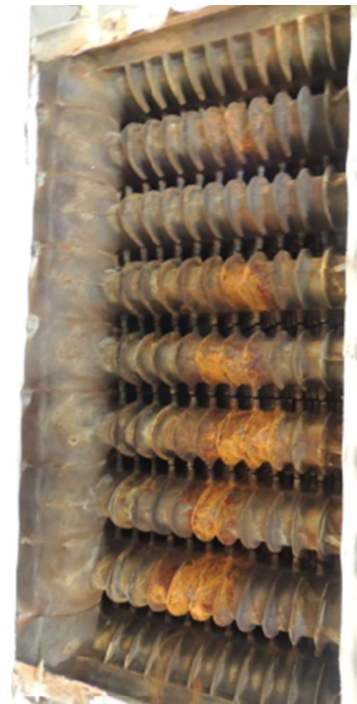
Multiple sections fractured
